HV Cable Management – doing it digitally

Graham Earp, Principal Consultant Engineer, EA Technology

IAM Asset Management Conference 2019, Liverpool

Case Study - British Steel

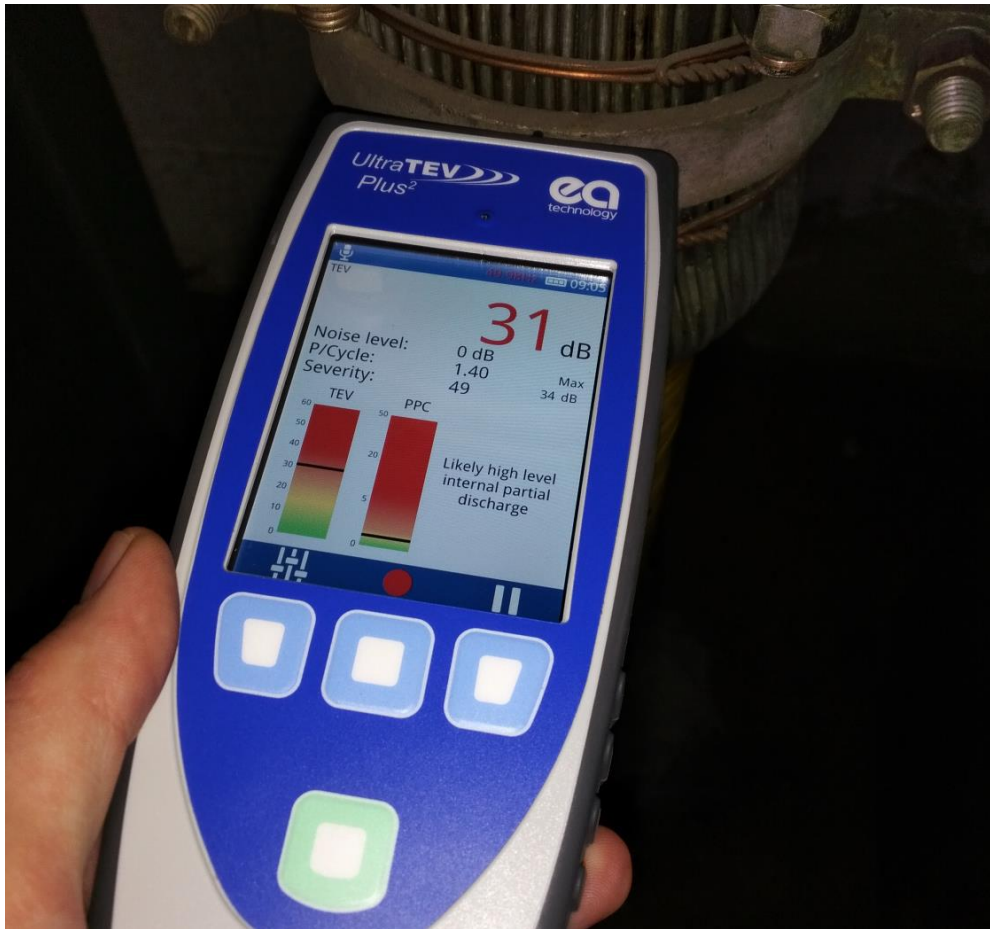
Developing cable fault

Initially confirmed by TEV measurement on steel armouring on central power station interconnector cable

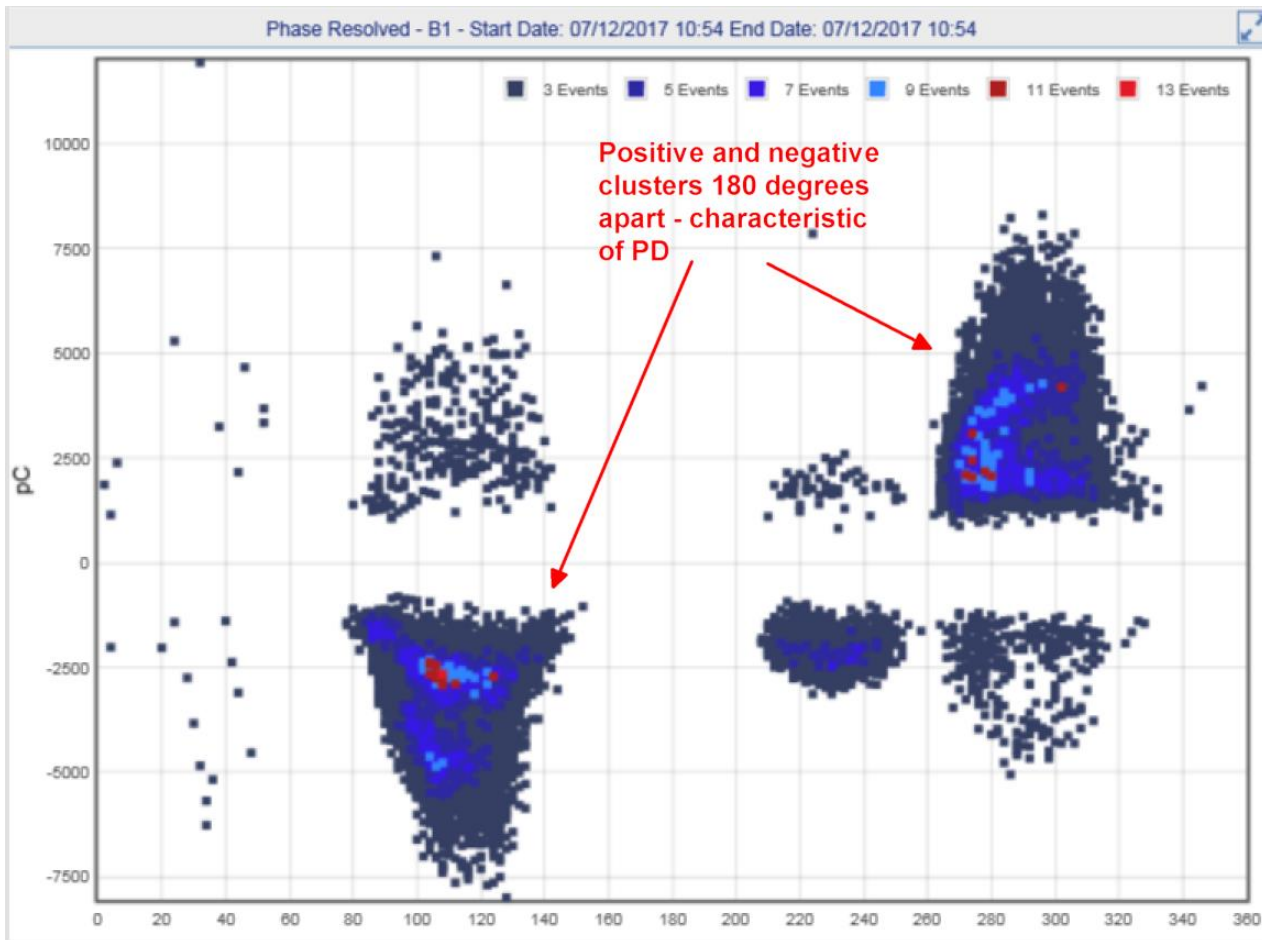
Phase plot

CableData monitor analysis

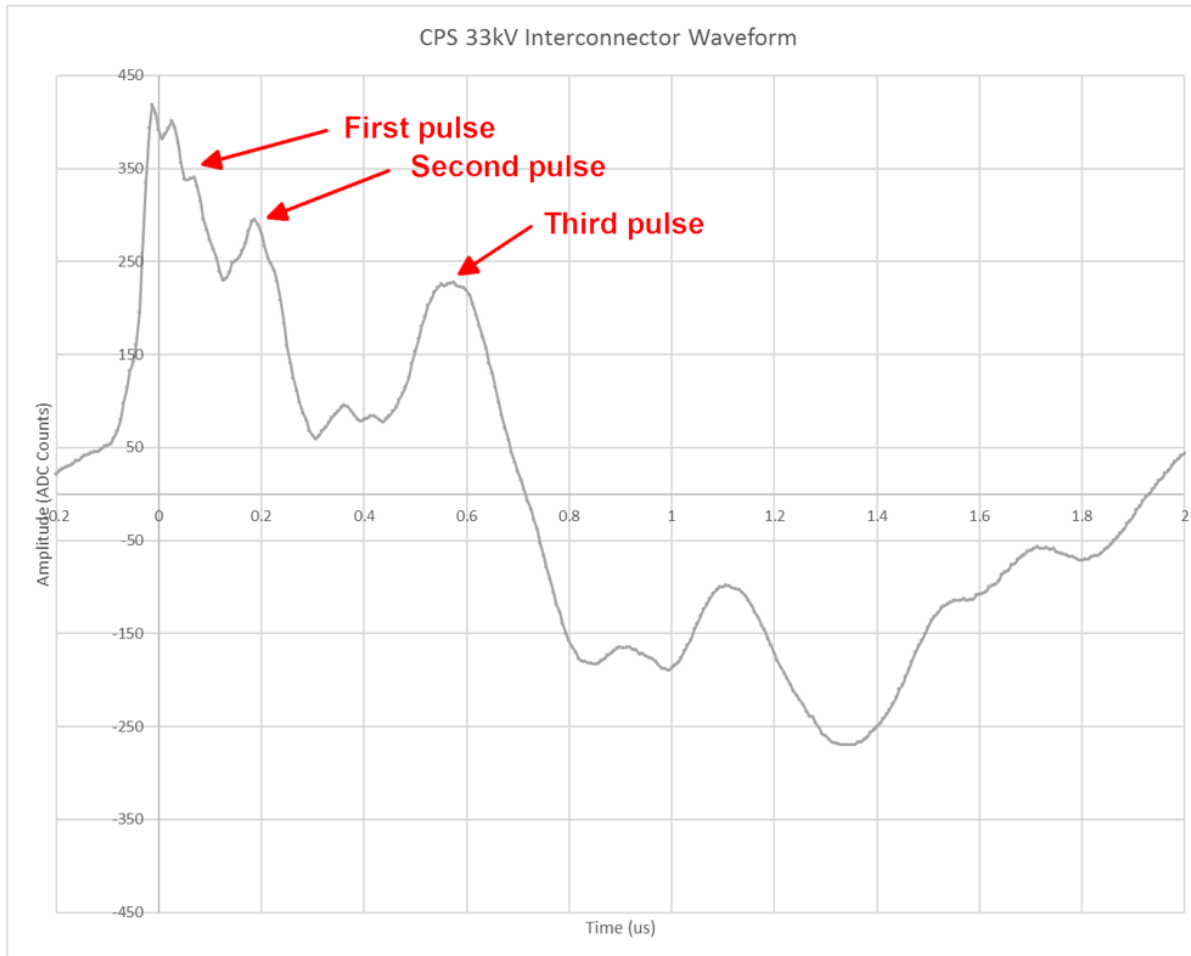
Waveform capture

Calculations from the pulse timings also put the source at 60% of the cable length out from the substation

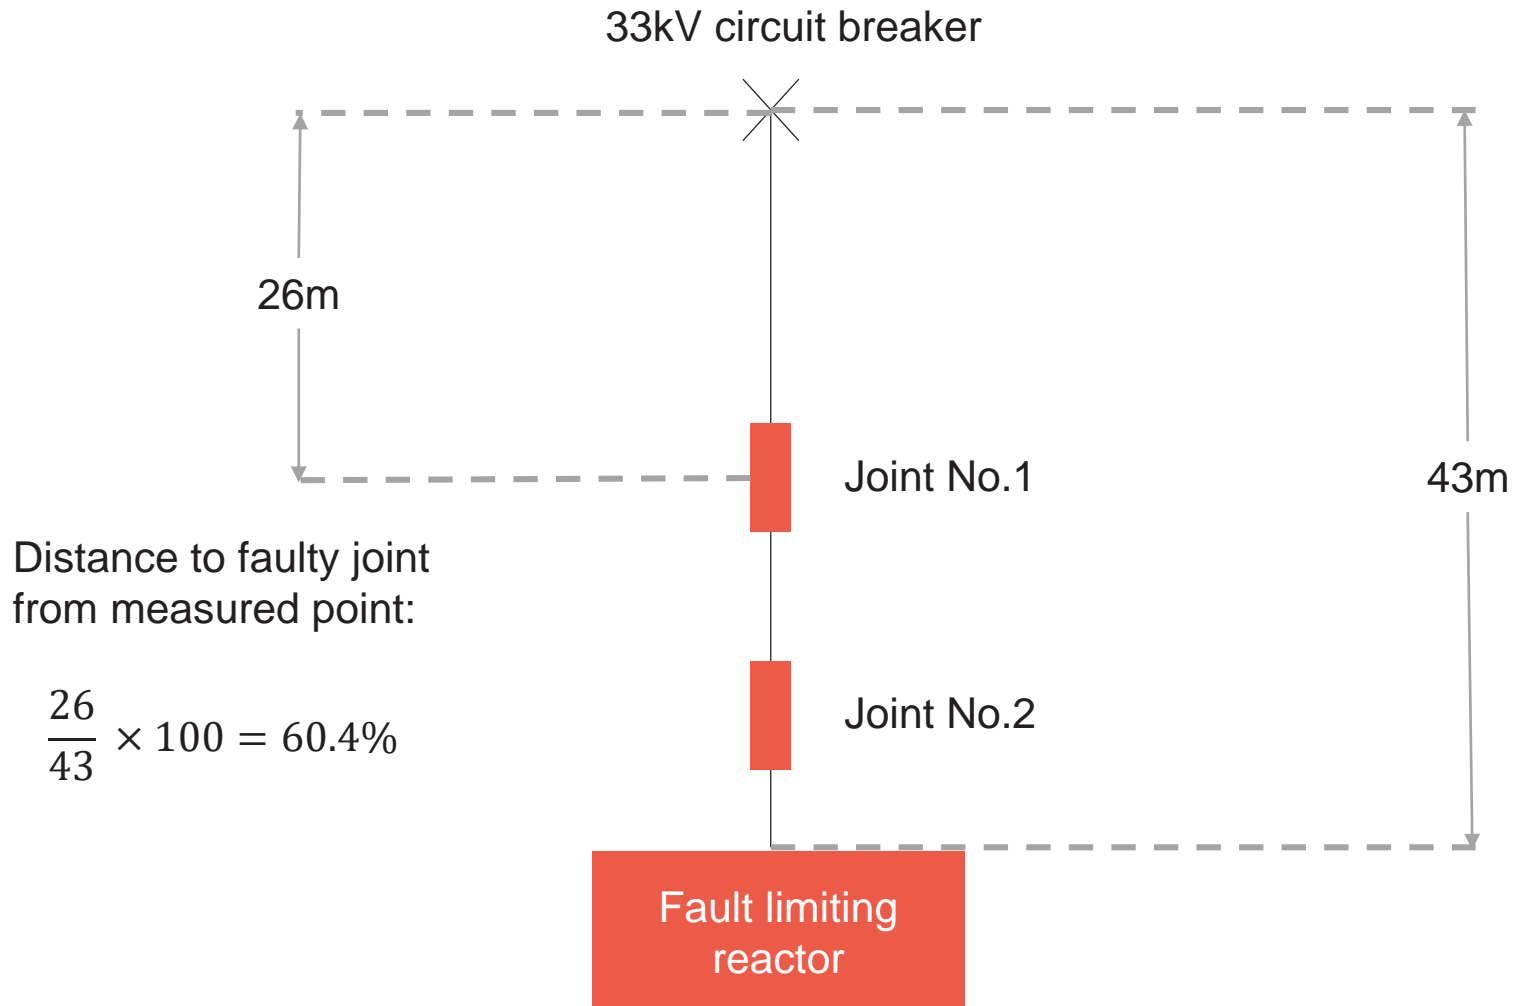
Cable layout details

- Plant drawings told us that there was only one joint in the cable.
- Initial results placed the Partial Discharge where a joint was not shown.
- Discussions with plant engineers determined an additional joint had been installed approx. 10-20 years ago, drawings not updated.
- With legacy sites, the value of updating documentation was not as valued in the past.
- Digital technology can help us to map these circuits.

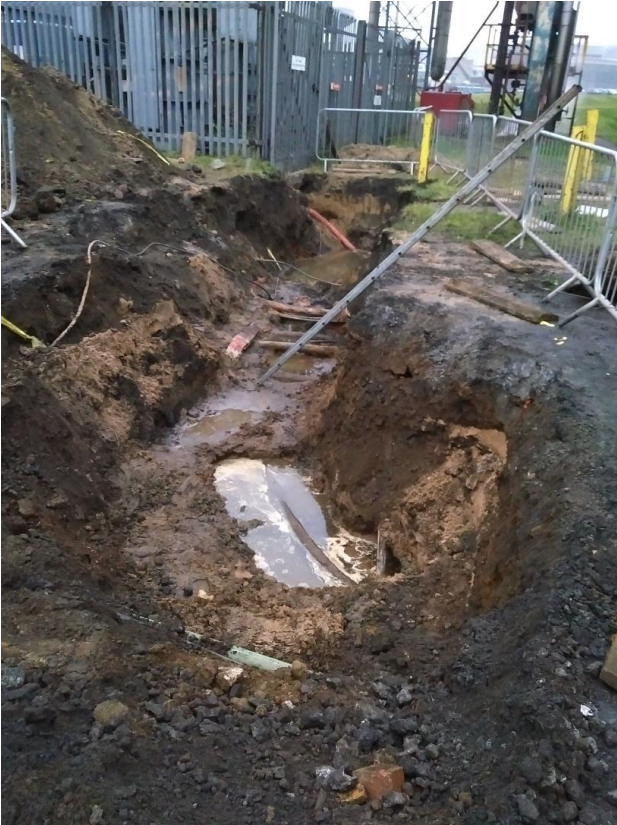
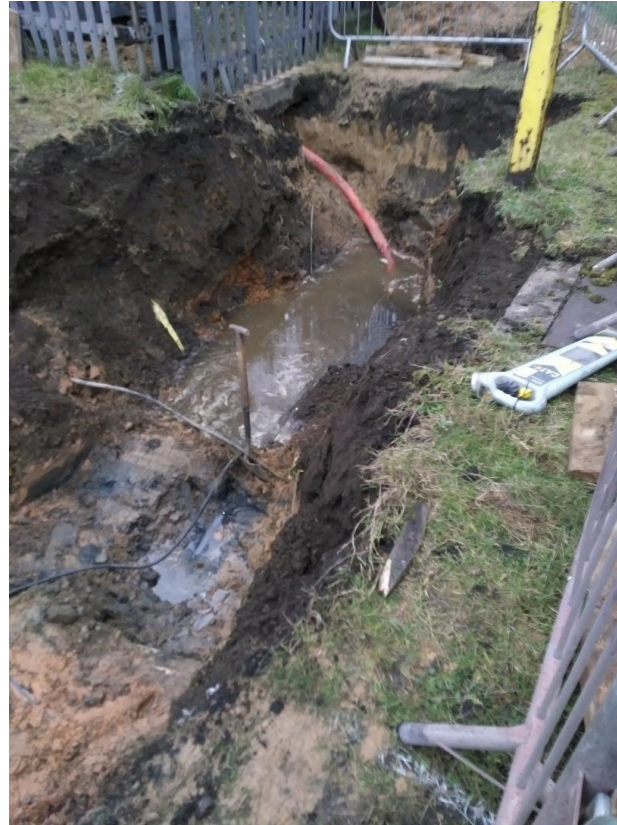
- Approval from senior management to excavate suspect joints and replace
- Excavation completed and suspect joint position found to have been installed in a ground water drain

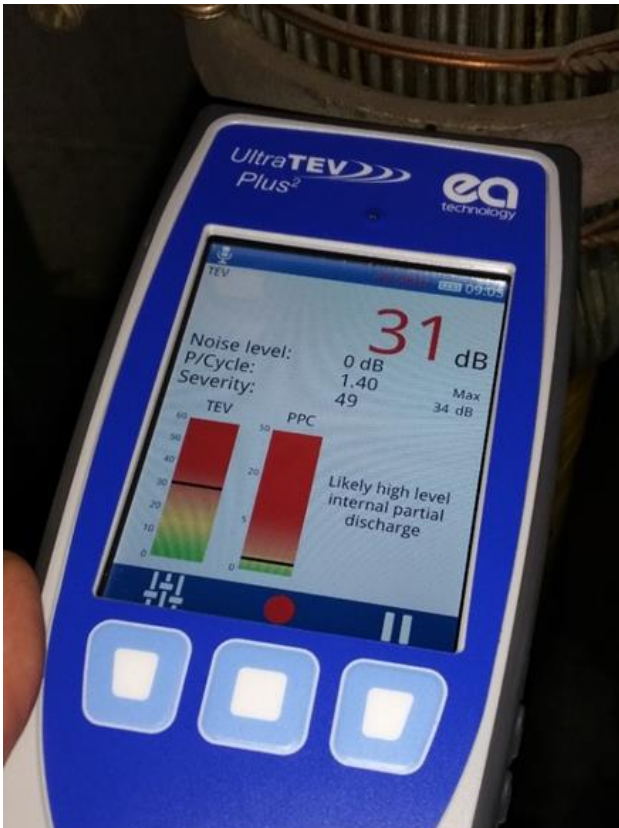
Before (31dB)

Re-energisation of the circuit showed a large reduction in the TEV magnitude present on cable armour
